## **Testing a Prefabricated Floor System**

Prepared for: Lee O'Connor  
Director  
Grants of Shoreditch Ltd

21 October 2005

Client report number 226-135

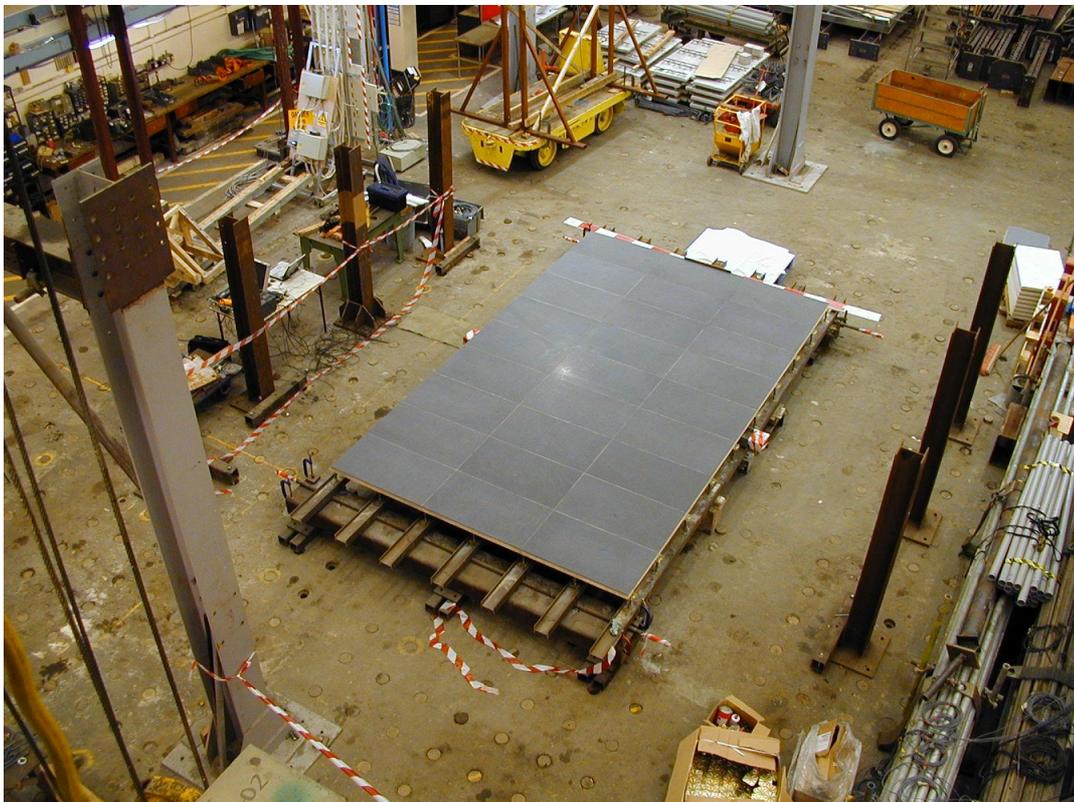
Figure 1. General view of floor constructed for deflection and rolling load testing at BRE.

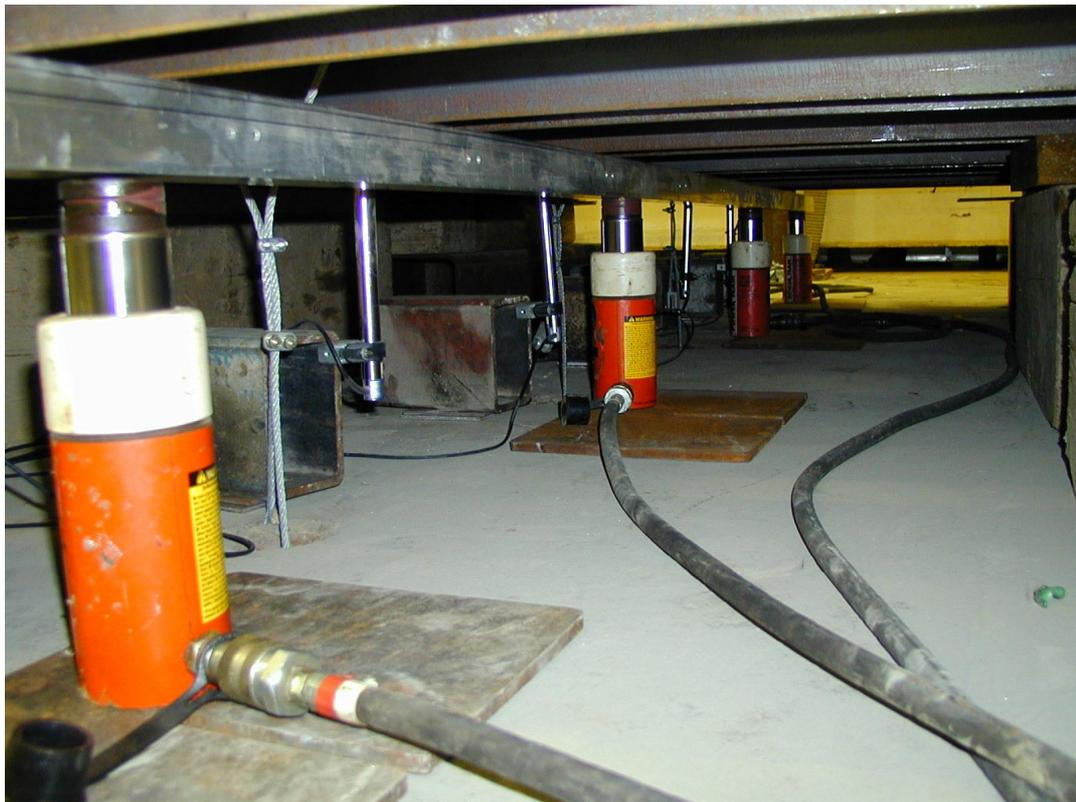
Figure 2. Hydraulic jack arrangement providing control for deflection testing.

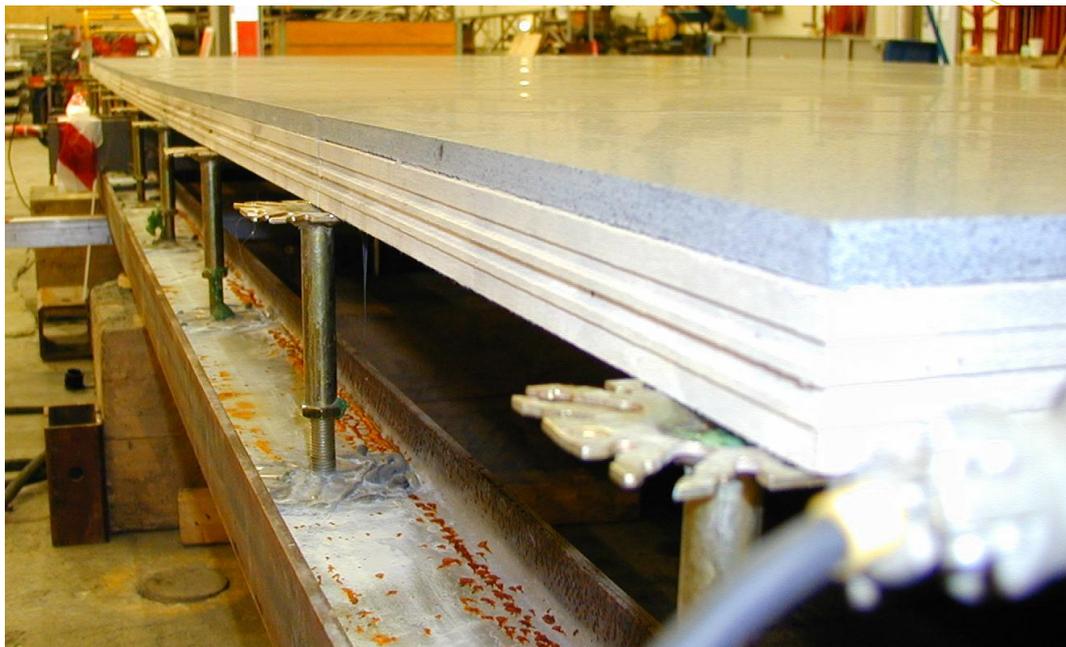
Figure 3. General view of floor panel system, sitting on pedestals for test.

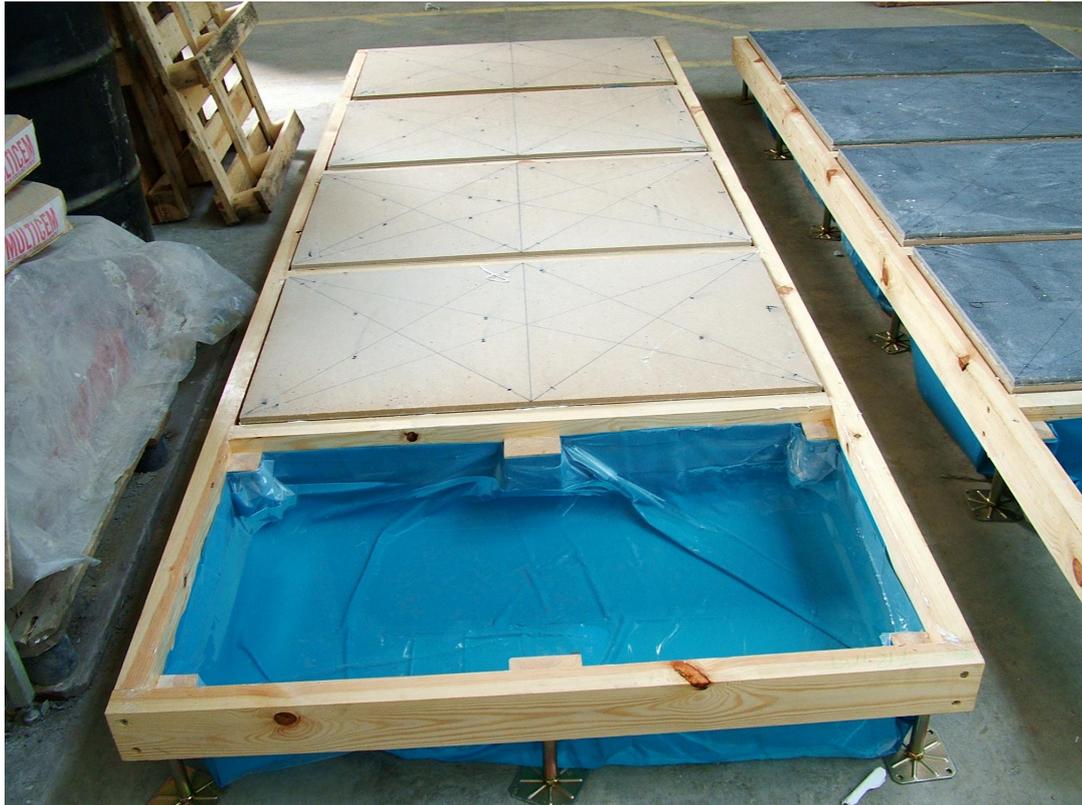
Figure 4. General arrangement of the durability test rig.
